UPPER HUDSON RIVER WATERSHED
JACKSON CREEK BASIN

JACKSON SUMMIT RESERVOIR DAM
FULTON COUNTY, NEW YORK

NY 153
PHASE I INSPECTION REPORT
NATIONAL DAM SAFETY PROGRAM

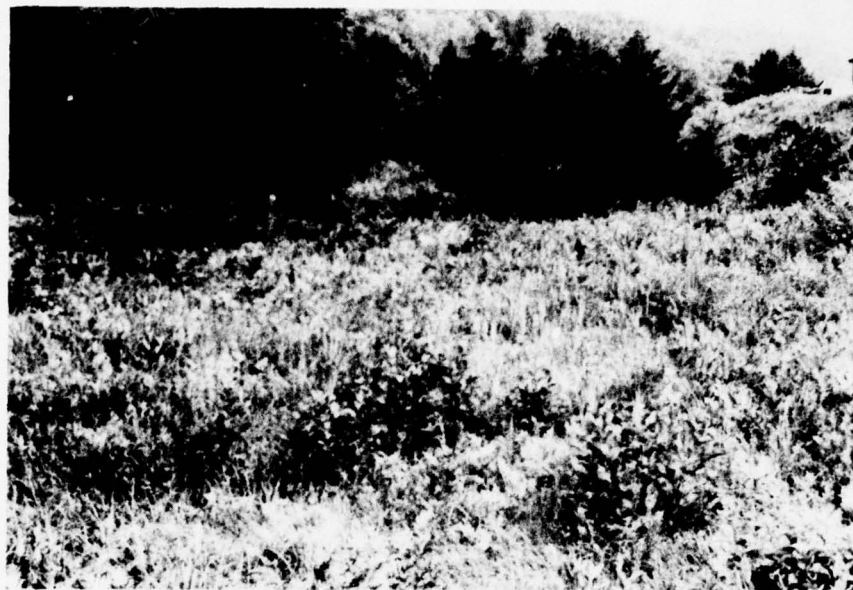
Inspection of the downstream face of the embankment revealed no evidence of seepage. However, approximately 50 feet downstream of the embankment toe, a seepage channel was noted (Fig. 4, Appendix D) which carried a clear steady flow of water into Jackson Creek. It was observed that the ground was swampy from approximately 50 feet downstream of the embankment toe to beyond the dirt road starting about 100 feet left of the gate house and continuing along almost the entire length of the dam (Fig. 5, Appendix D). All seepage observed occurred in virgin soil. A boil was noted at the outlet of the 16-inch diameter corrugated galvanized iron pipe culvert which allows the seepage runoff to pass under the Jackson Summit Road (Fig. 6, Appendix D). The soil was agitated creating a cloudy suspension of material. After

FIGURE 5 SWAMPY AREA DOWNSTREAM OF TOE

The occurrence of extensive amounts of seepage beyond the toe of the embankment warrants further investigation. It is recommended that the nature, strength properties and seepage characteristics of the embankment and foundation materials be established through a soil exploratory and testing program. The stability of the embankment may then be analyzed in the light of the new findings, and any necessary measures to reduce or control flow established.

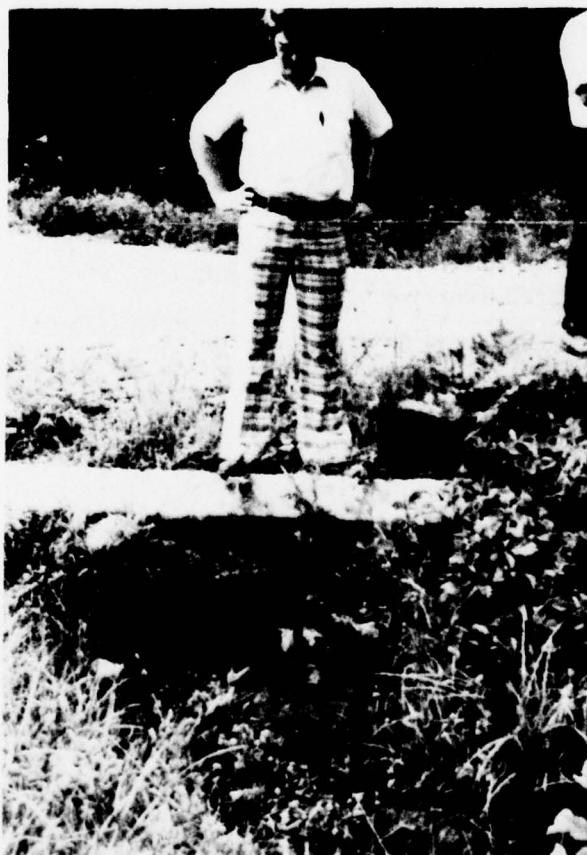
FIGURE 6 16-INCH CORRUGATED PIPE UNDER JACKSON SUMMIT ROAD

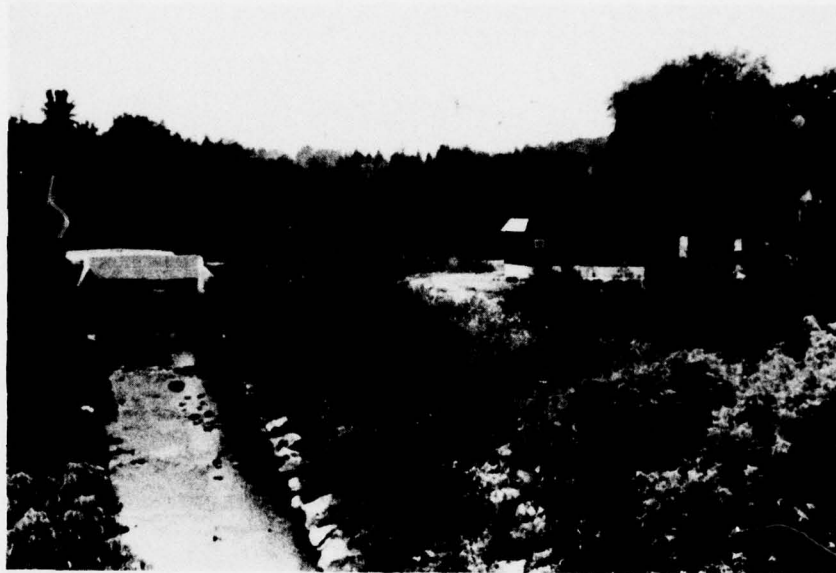
The downstream channel (Fig. 18, Appendix D) leading to Mayfield Lake is clear and free of debris. The channel itself is a natural stream with heavily vegetated and wooded slopes; the slopes appear stable. Immediately below the spillway is the caretaker's home, and about 1 mile downstream in Mayfield (Figs. 19 and 20, Appendix D), several houses and trailers are situated in a flood plain area.

FIGURE 19 JACKSON CREEK IN MAYFIELD, NEW YORK

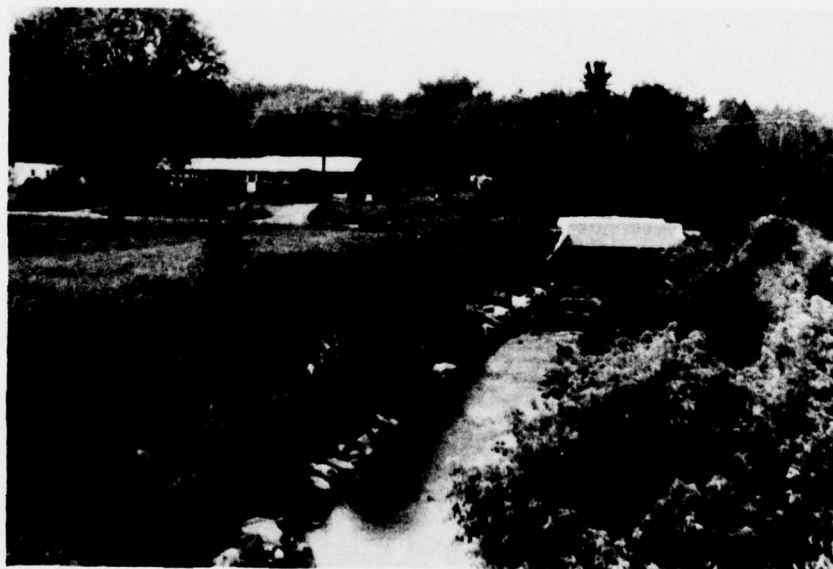
FIGURE 20 JACKSON CREEK IN MAYFIELD, NEW YORK
